Gear Failure Analysis

Macropitting

Background Information, Definitions

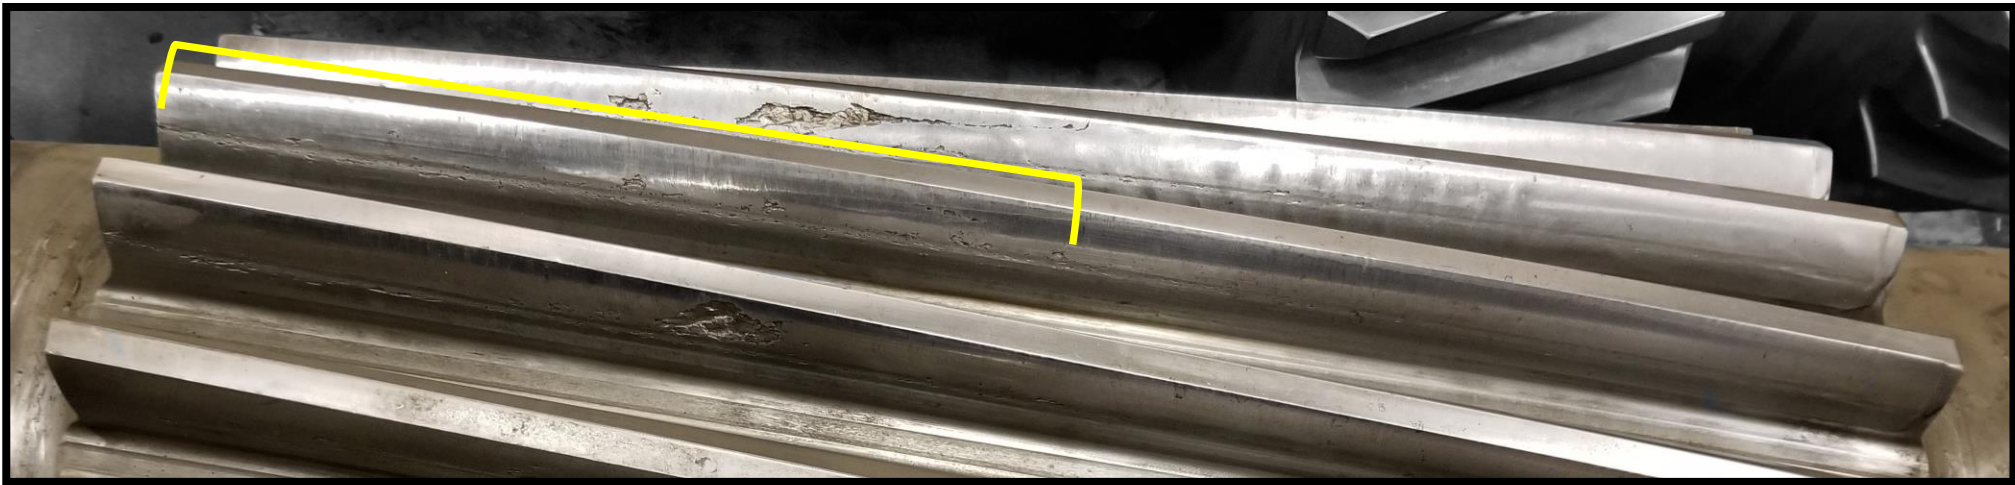
- Wear, macropitting and spalling, concentrated on the left side of the tooth
 - Bearing position misalignment (housing)
 - Tooth lead error (pinion and gear)
 - Gear runout to shaft's bearing journals
 - Shaft bending and torsional deflection

Wear shifted to the left side of the tooth width

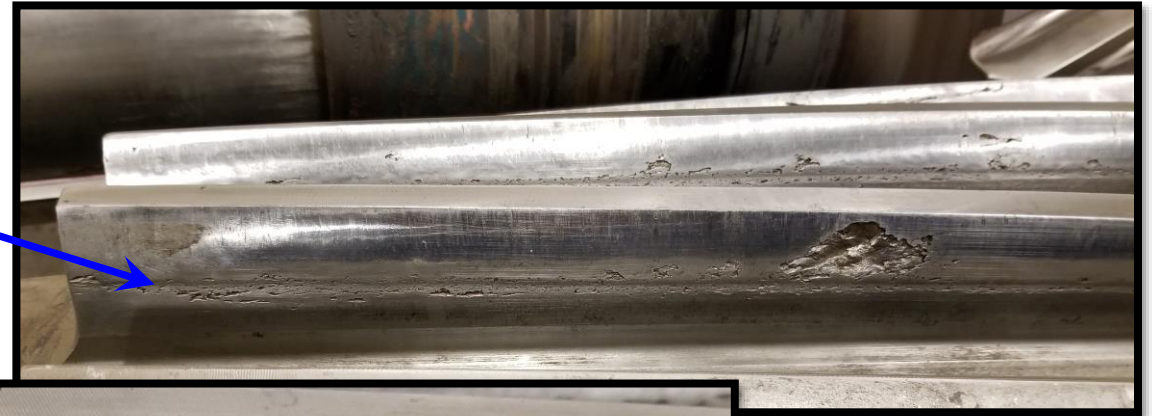
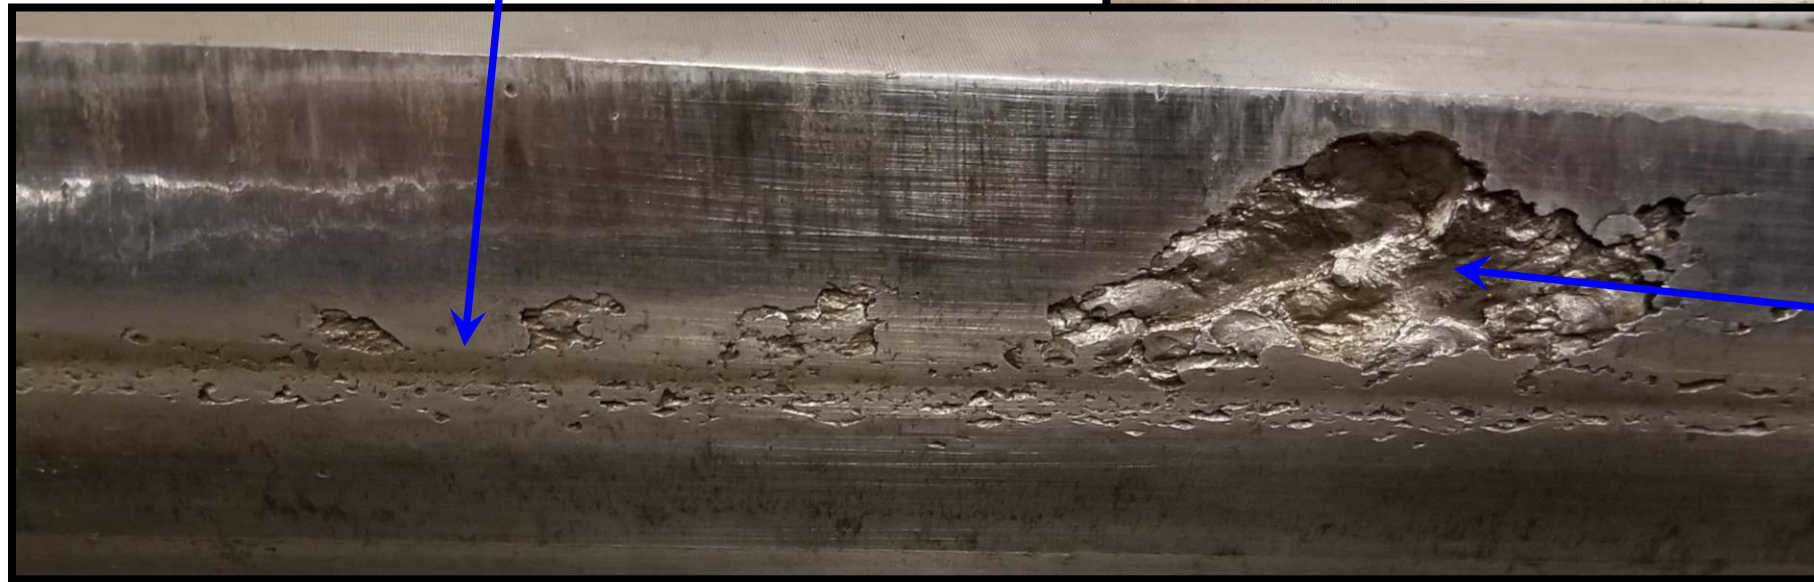
Macropitting

Macropitting concentrated at pitchline

Pitting at the pitchline propagates into the addendum - spalling

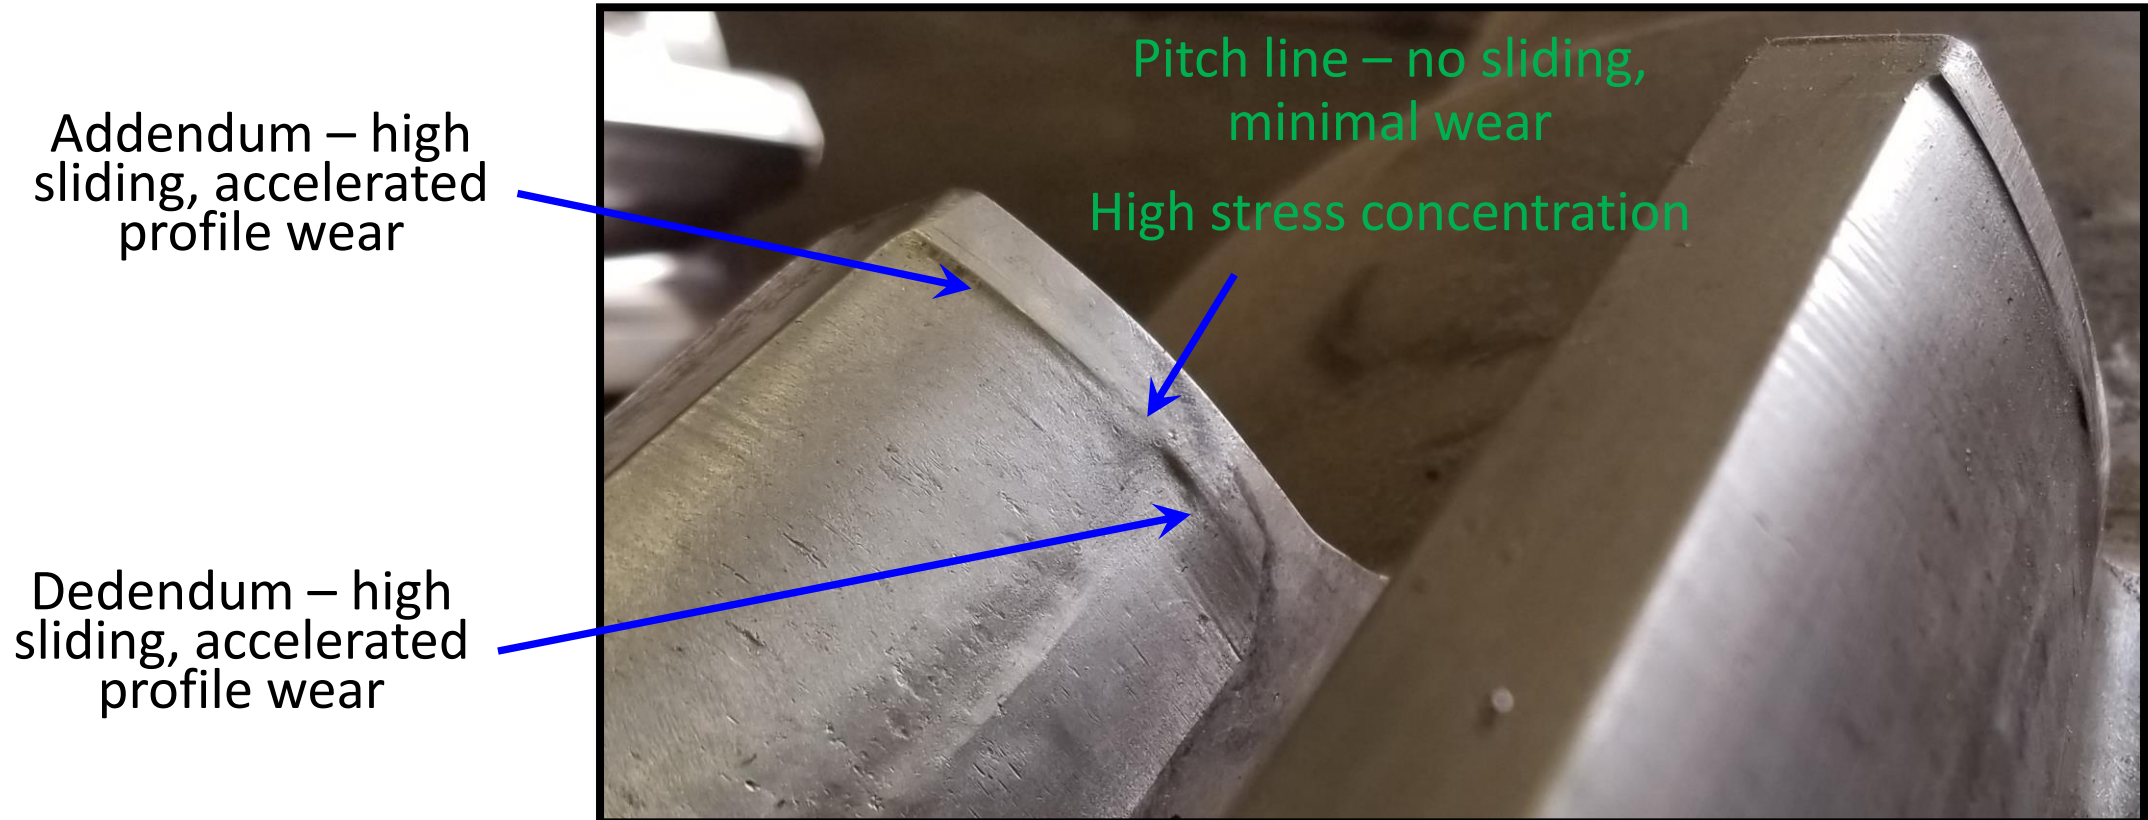
Tooth Profile Wear

- Addendum and dedendum wear
